# LAYTONVILLE LANDFILL 2025 PUBLIC MEETING UPDATE

Dr. Dietrick McGinnis PE CEM

McGinnis and Associates

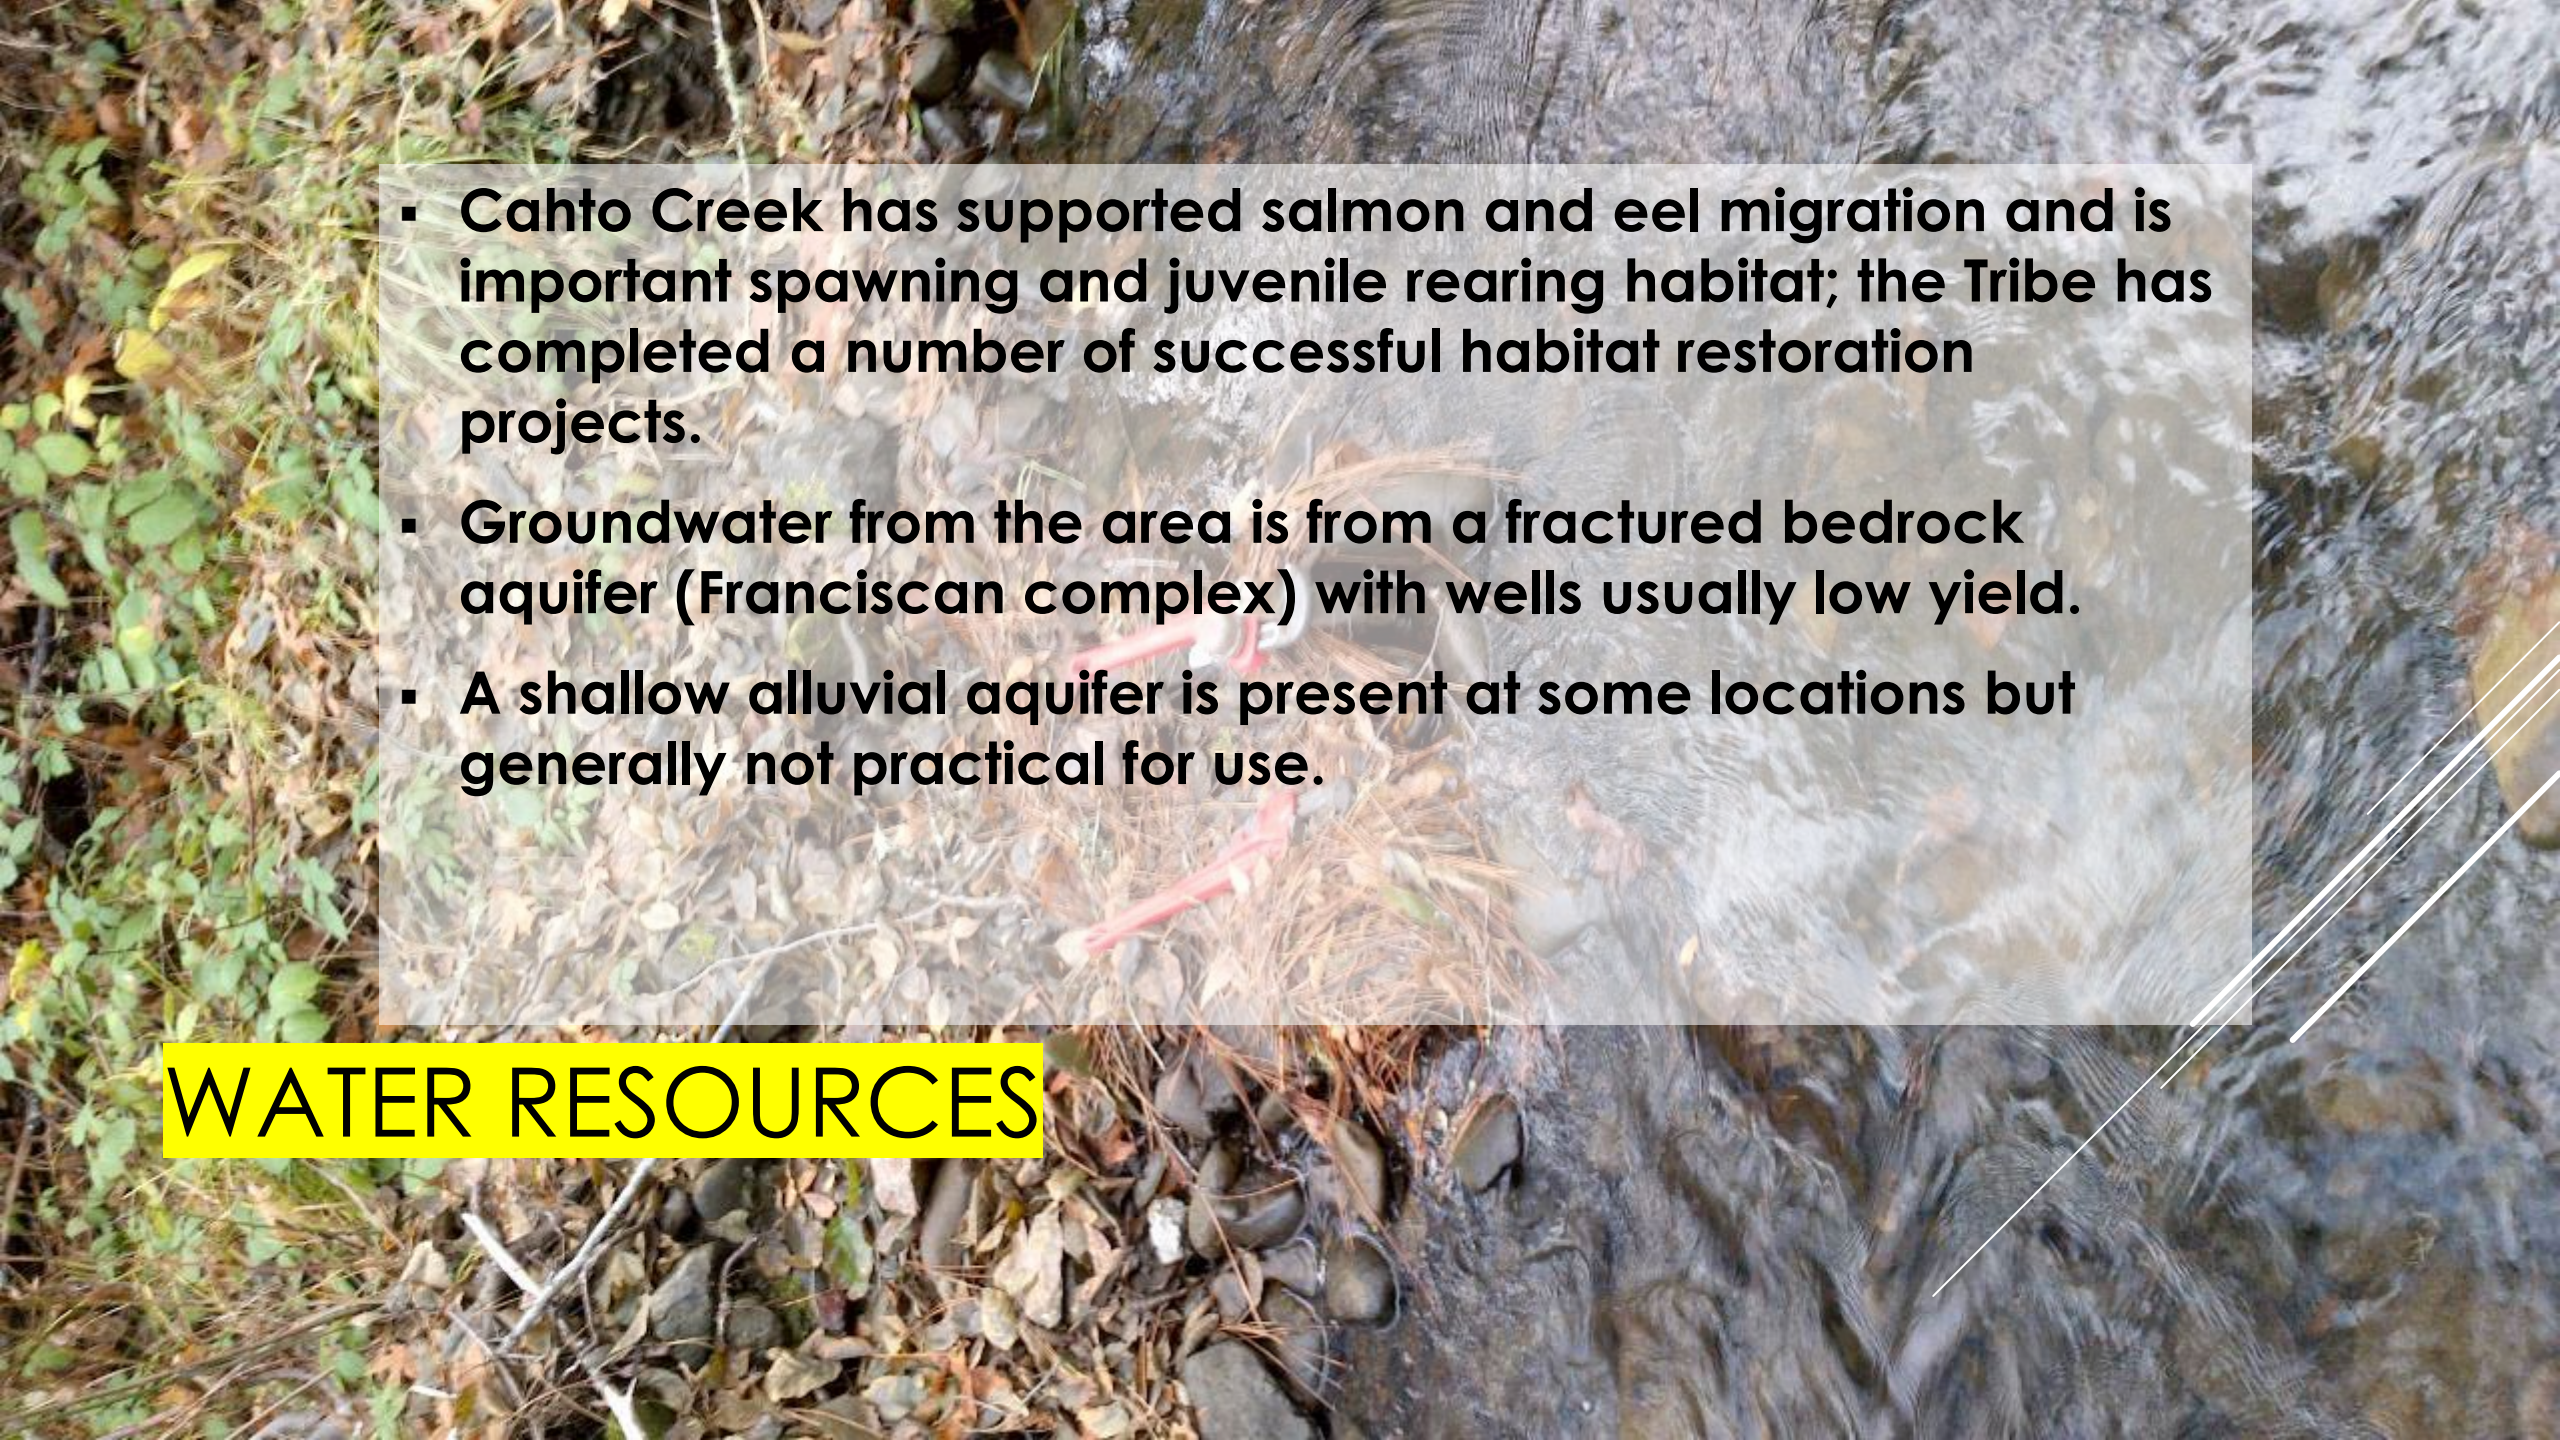
- A photograph of a stream with a pink salmon in the water. The water is clear and flowing over rocks. The banks are covered with green and brown vegetation. A semi-transparent text box is overlaid on the image.
- Cahto Creek has supported salmon and eel migration and is important spawning and juvenile rearing habitat; the Tribe has completed a number of successful habitat restoration projects.
  - Groundwater from the area is from a fractured bedrock aquifer (Franciscan complex) with wells usually low yield.
  - A shallow alluvial aquifer is present at some locations but generally not practical for use.

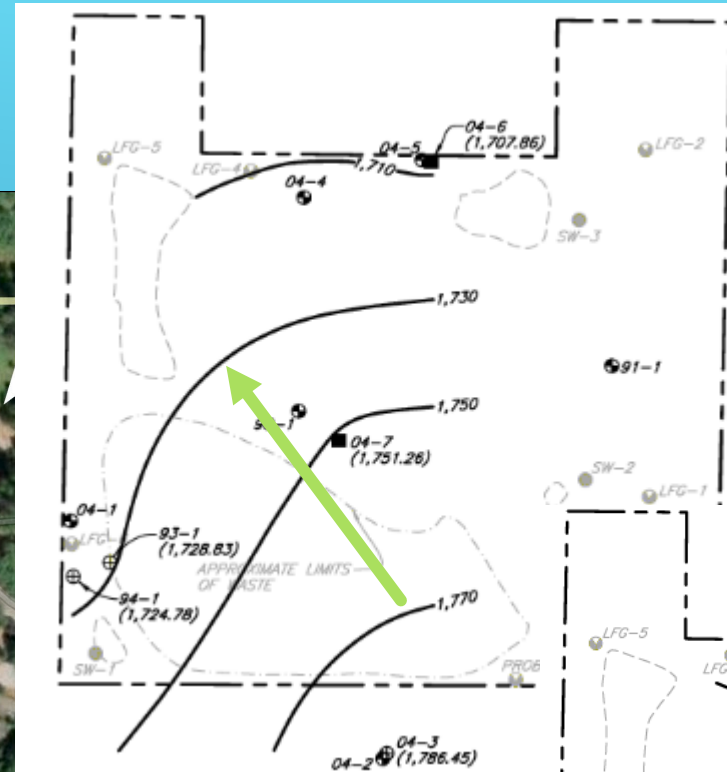
2019 Landfill Groundwater Elevations, "Franciscan Wells"

Groundwater flow direction as indicated in landfill site reports

- ▶ The groundwater flow direction as indicated in landfill site reports does not agree with the Rancheria data, likely a Conceptual Site Model (CSM) issue (dividing the wells into inappropriate groups)
- ▶ Local well logs do not agree with the CSM
- ▶ The groundwater well design appears to disregard local groundwater use and nearby well design
- ▶ Releases to groundwater appear to be occurring on the Rancheria
- ▶ Groundwater flow appears to be from the landfill site toward Cahto Creek
